FINAL REPORT
MAY 1993

REPORT NO. 93-20

TRANSPORTATION TEST OF
M876A1 U.S. MARINE CORPS
(USMC) TELEPHONE
MAINTENANCE TRUCK (TMT)

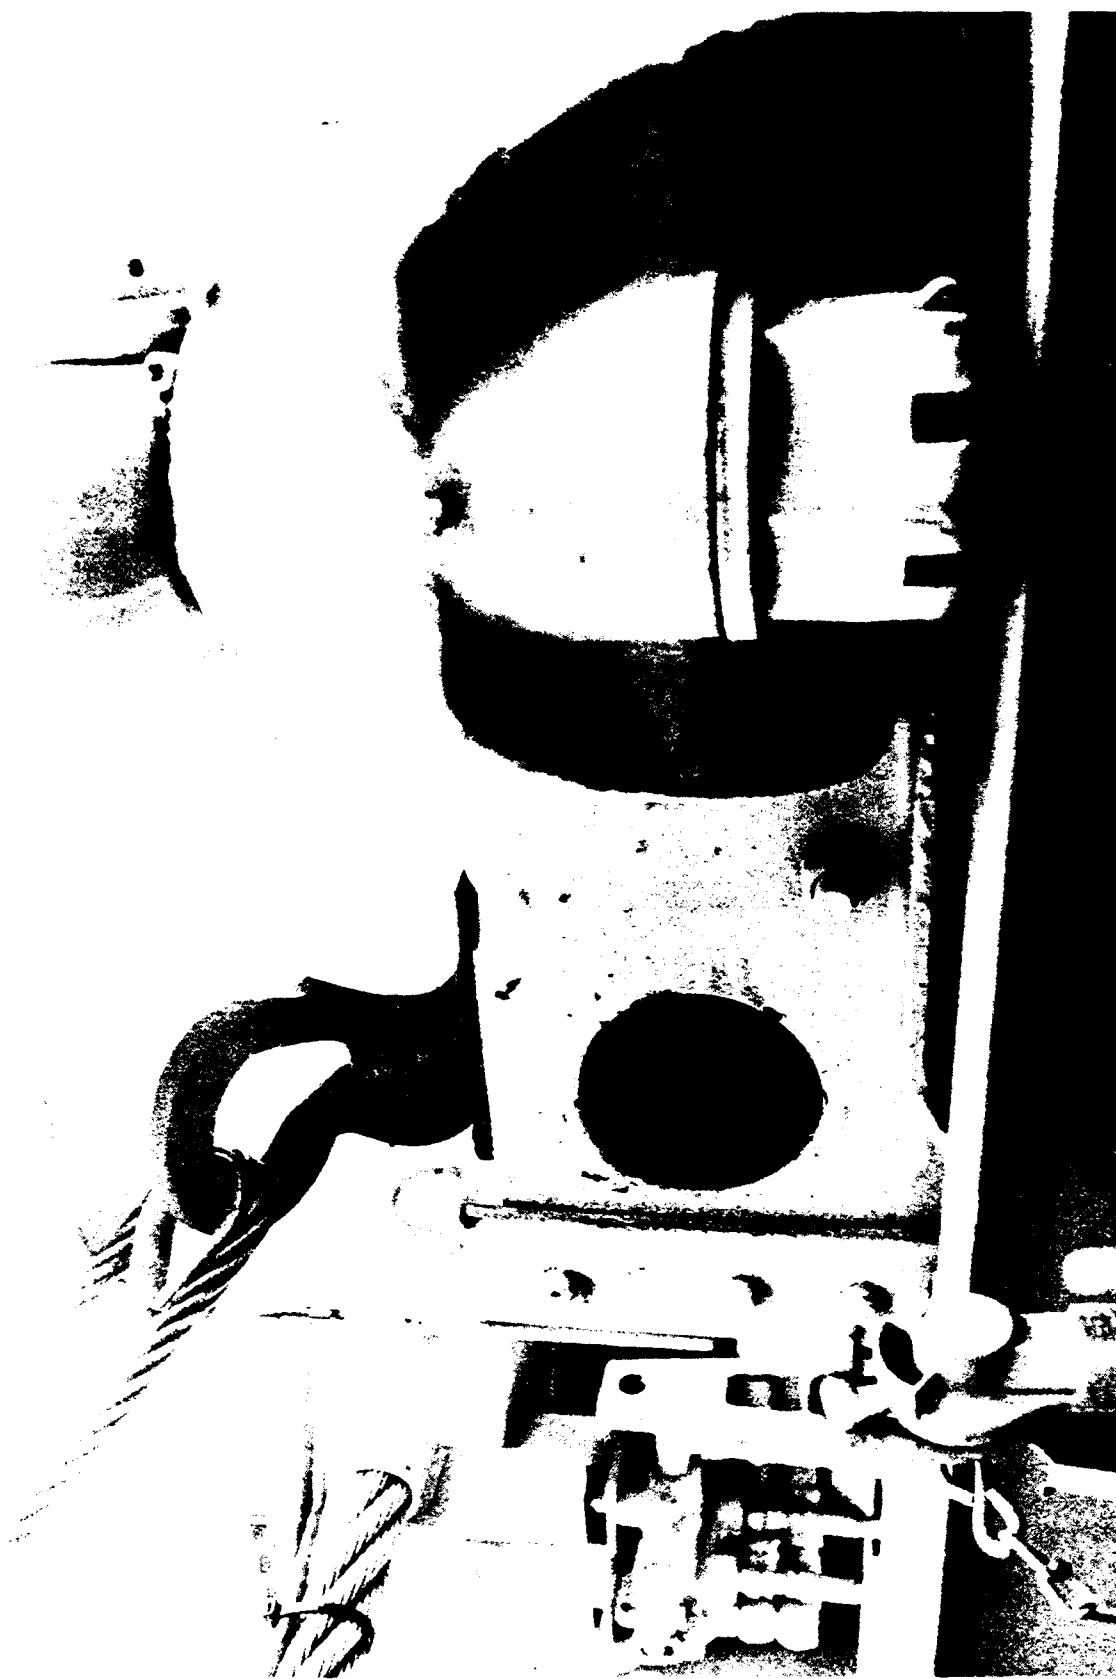
PHOTO NO. A0317-SCN93-152-1887. This photo shows the clevis mount on the left side of the M876A1 TMT after a rail impact with the replaced clevis mounts. Note the deformation in the end of the lateral crossmember. Deformation occurred because the metal was not thick enough to support the load. The M939A2 chassis has a reinforcing plate behind the lateral crossmember.

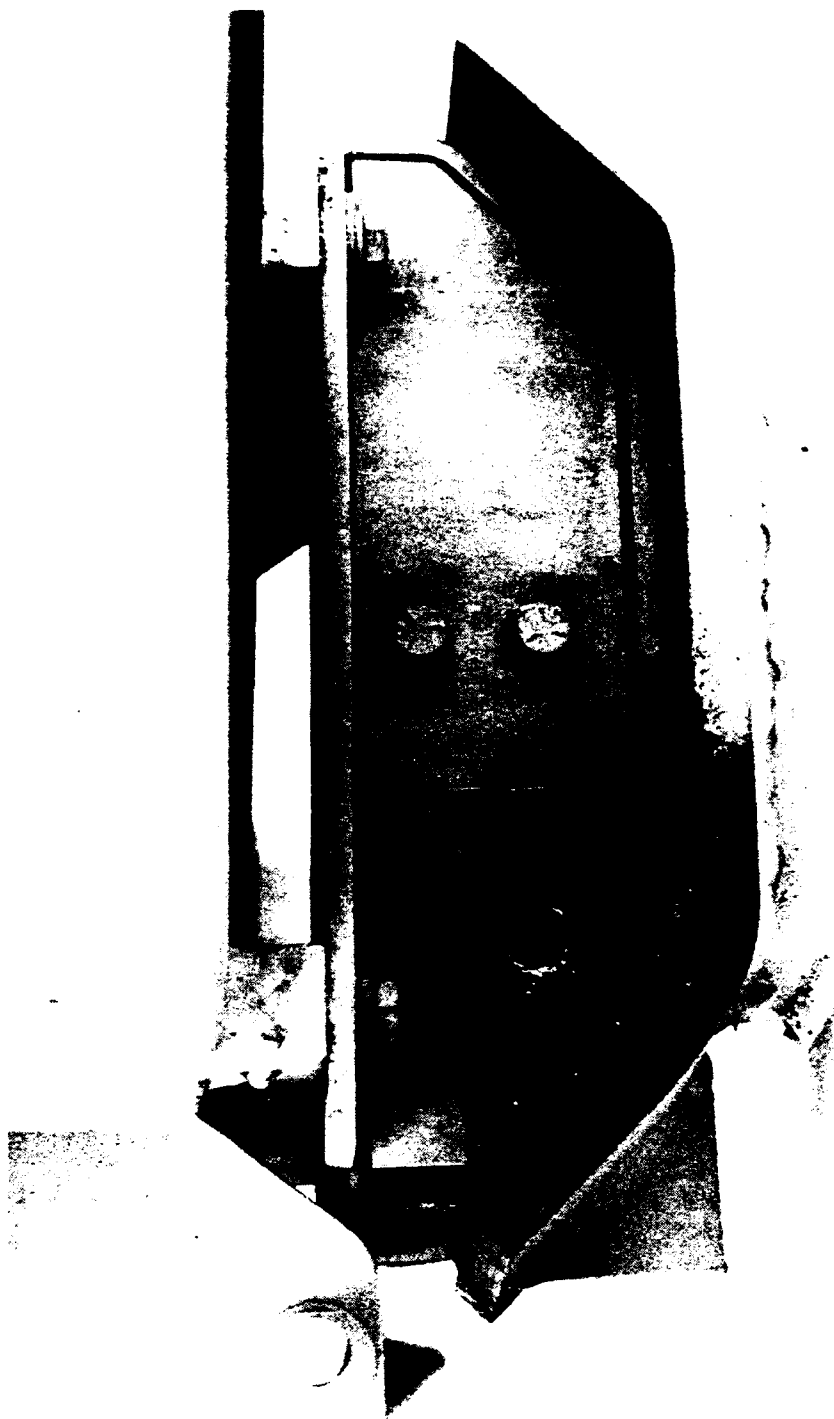
PHOTO NO. A0317-SCN93-152-2233. This photo shows the TMTB boom rest pedestal with the boom in the stowed position. A plate was welded to the pedestal and drilled through for a pin to lock the boom to the pedestal. The bolts used to secure the boom pedestal interface were resecured with Locktite adhesive to prevent them from vibrating out while going through the road hazard course.

5. The TMTB boom should be mechanically locked to the boom rest stand. Any pin-type lock should be fabricated from material equivalent to grade 8 steel.

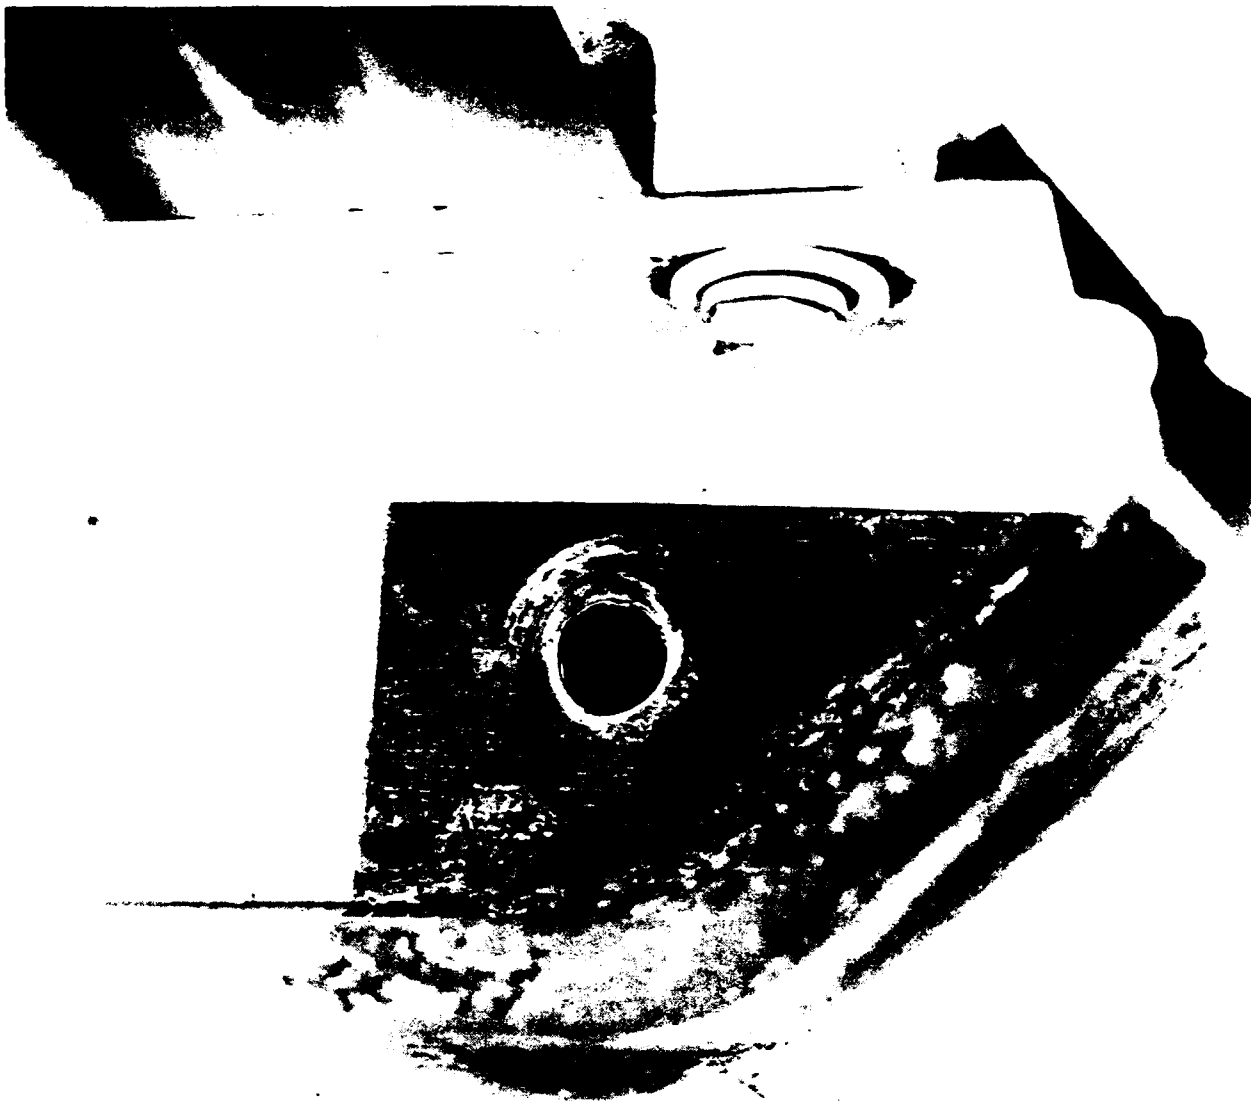
PHOTO NO. A0317-SCN93-152-2232. This photo shows the TMTB boom rest pedestal with the boom in the stowed position. A plate was welded to the pedestal and drilled through for a pin to lock the boom to the pedestal. The bolts used to secure the boom pedestal interface were resecured with Locktite adhesive to prevent them from vibrating out while going through the road hazard course.

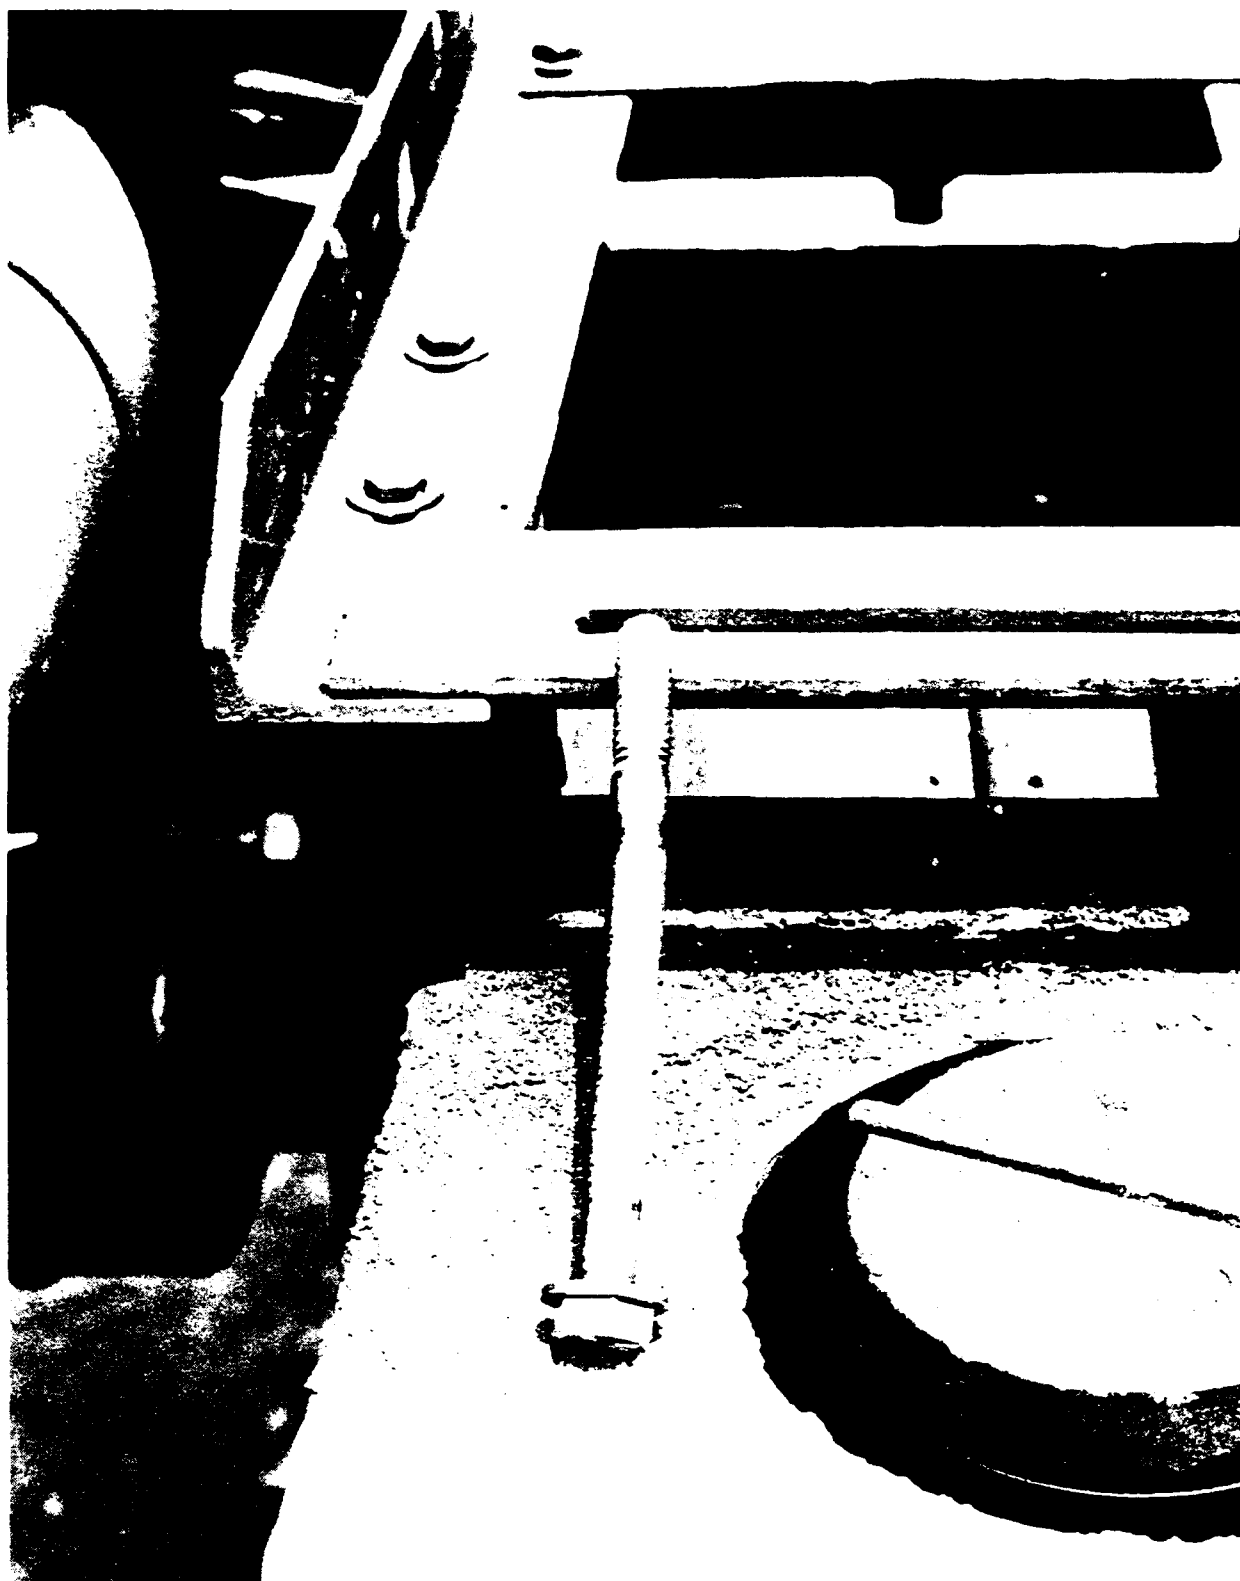
REMARKS: The pin used to secure the boom to the rest pedestal deformed after one pass over the course. It was replaced with a grade 8-equivalent steel bolt.

PHOTO NO. A0317-SCN93-152-2230. This bolt was originally used to secure the TMTB boom to the rest pedestal. Note the deformation. This bolt was replaced with a grade 8-equivalent bolt. No damage occurred to the grade 8 bolt during road hazard course testing.

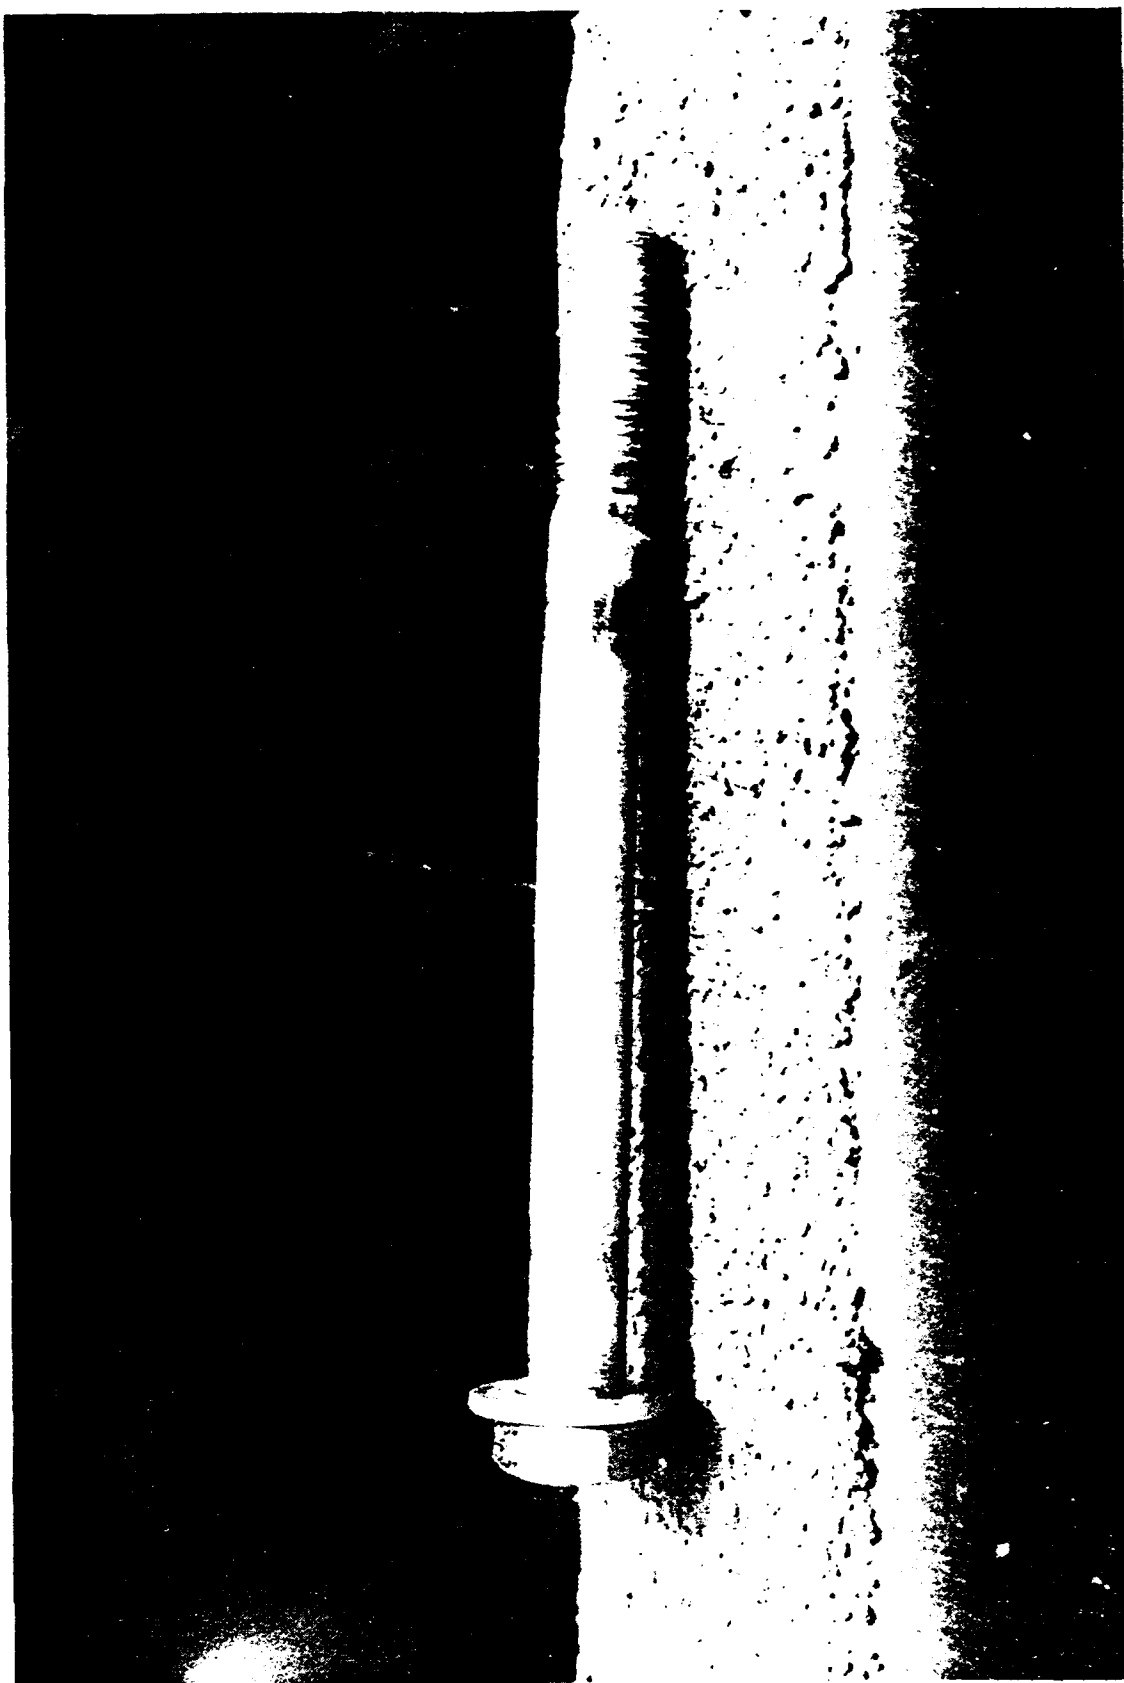
PHOTO NO. A0317-SCN93-152-2231. This bolt was originally used to secure the TMTB boom to the rest pedestal. Note the deformation. This bolt was replaced with a grade 8-equivalent bolt. No damage occurred to the grade 8 bolt during road hazard course testing.

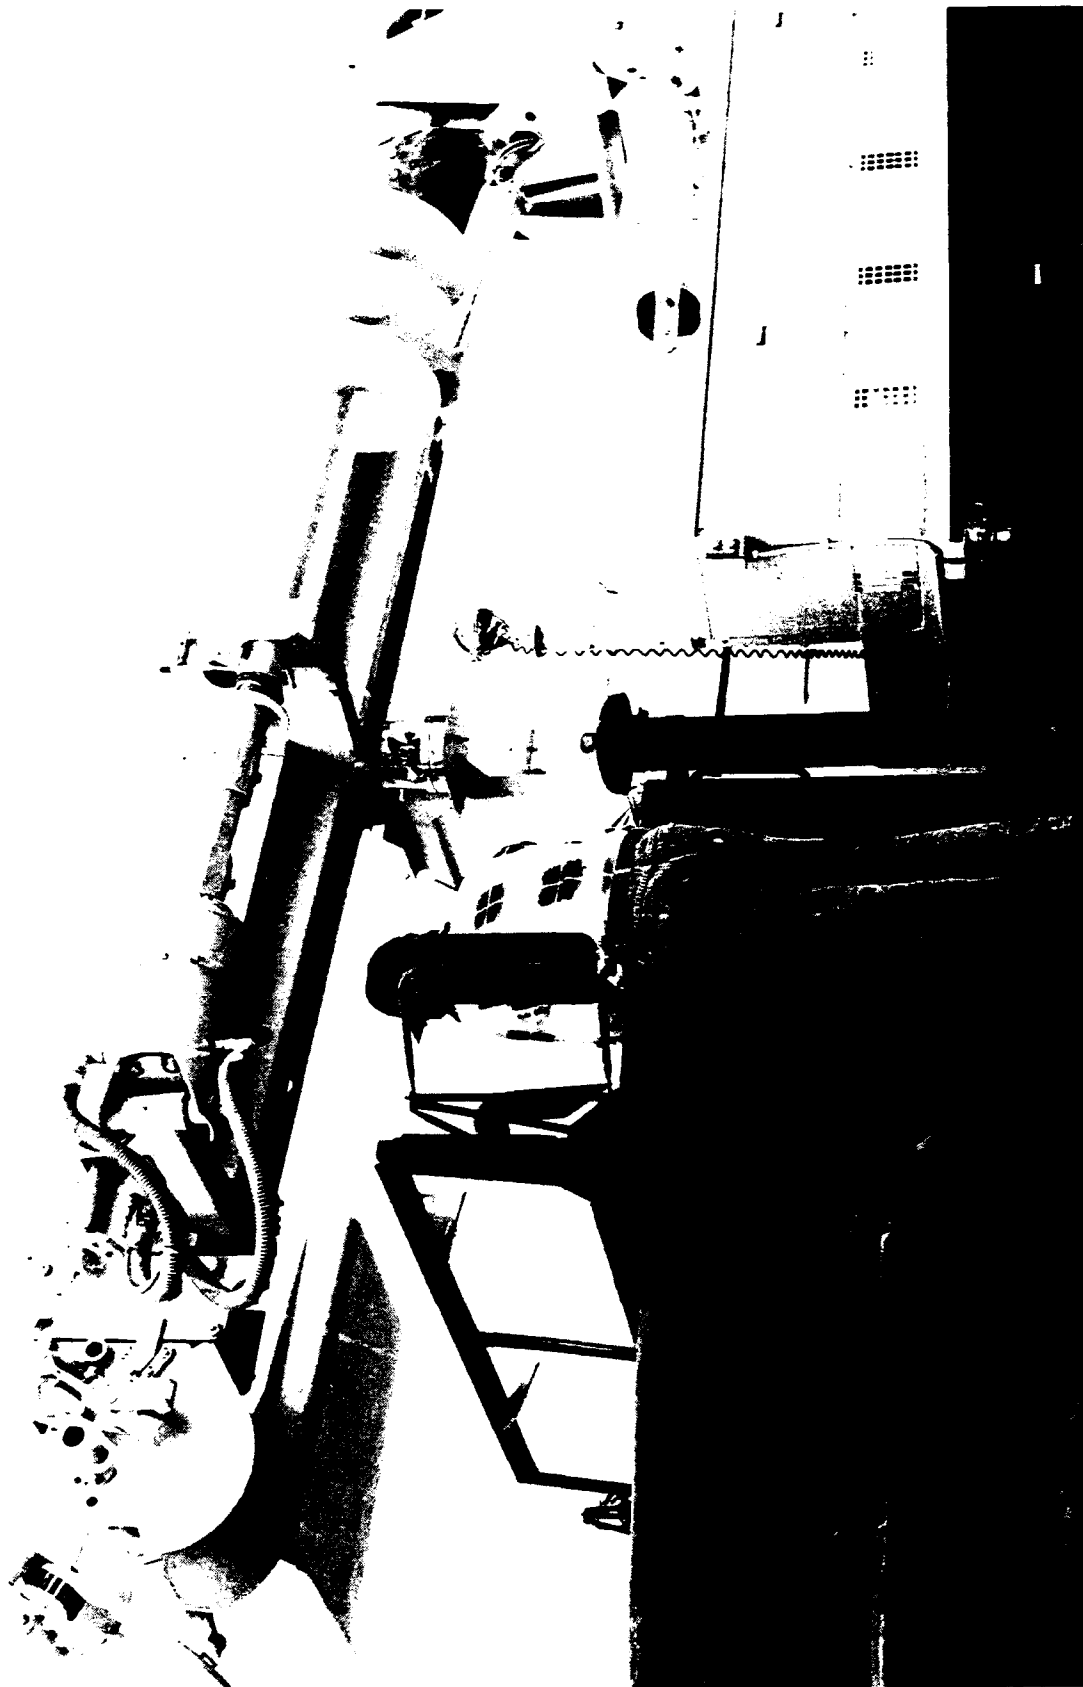
PHOTO NO. A0317-SPN93-152-1844. This photo shows the TMTB boom resting between the warning light and mounting pedestal. This is the result of driving the TMT over the road hazard course at 5 mph. The boom was not pinned to the pedestal; therefore, the boom broke the lens on the warning light.

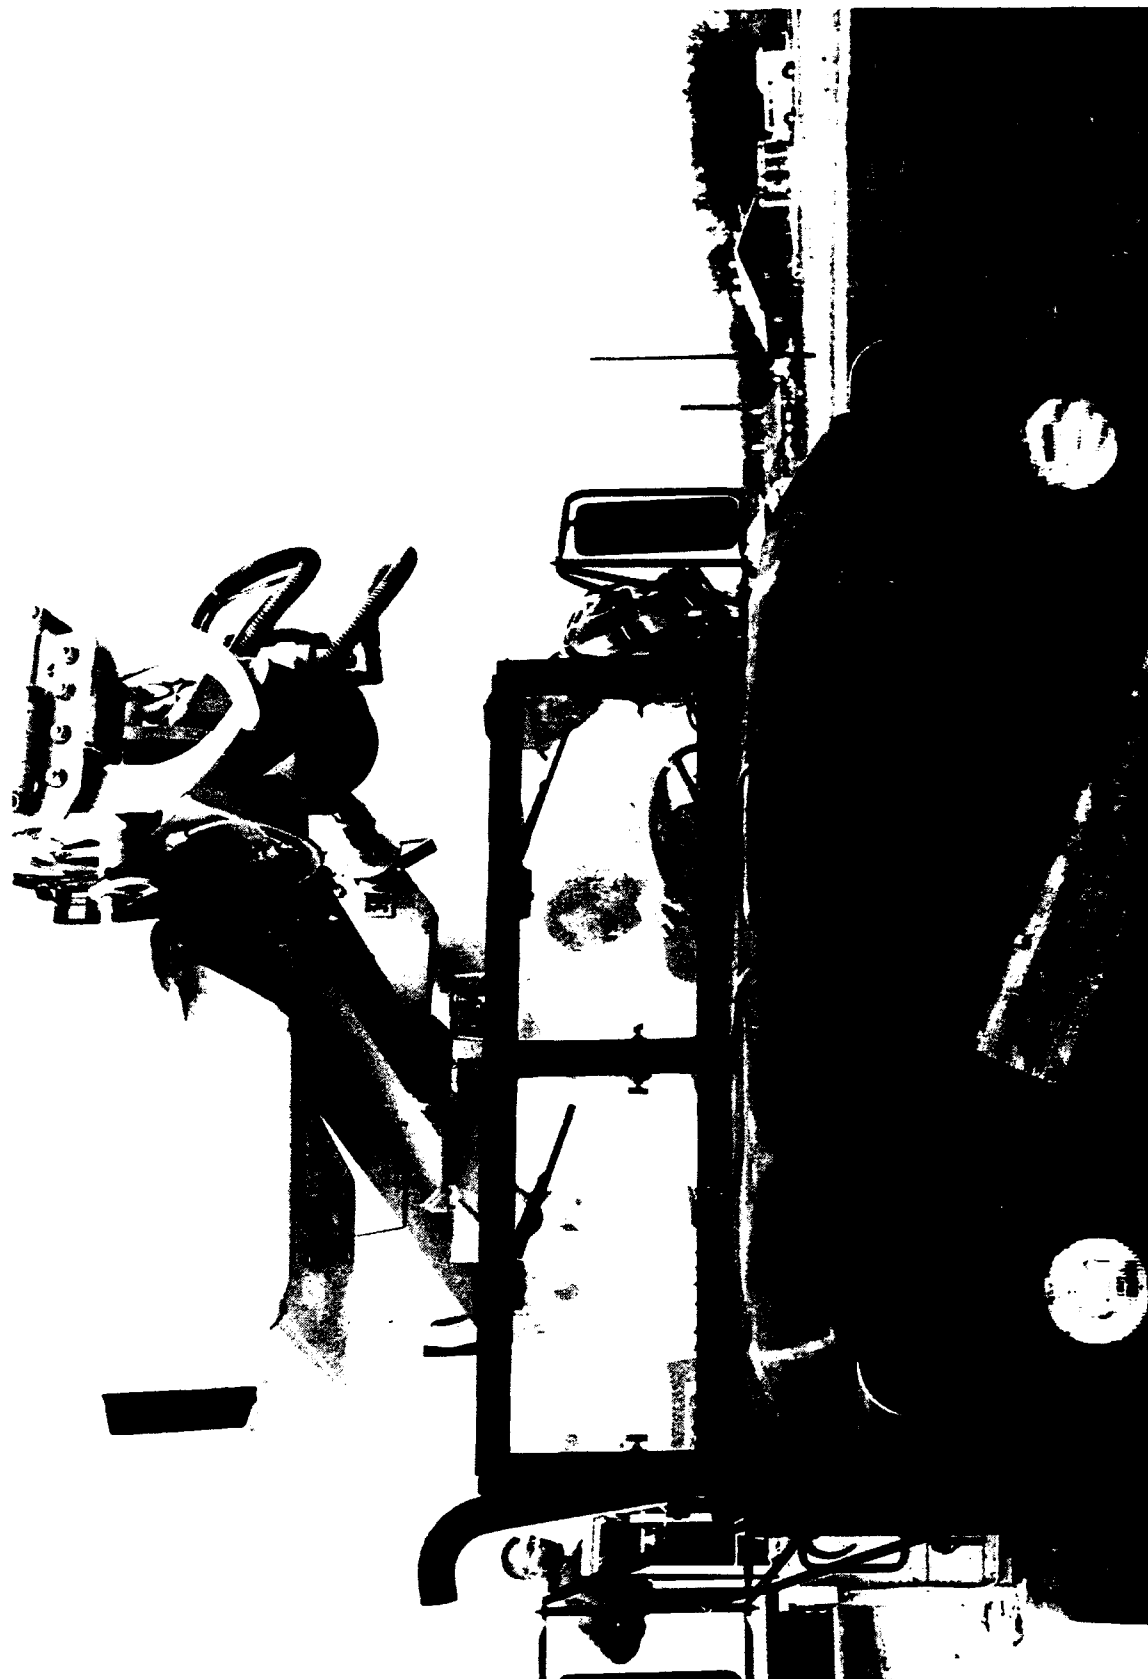
PHOTO NO. A0317-SPN93-152-1845. This photo shows the TMTB boom resting between the warning light and mounting pedestal. This is the result of driving the TMT over the road hazard course at 5 mph. The boom was not pinned to the pedestal; therefore, the boom broke the lens on the warning light.
